Home Report

Single Survey

Property address	Ladyburn 13 Main Street Glenluce Newton Stewart DG8 0PN
Customer	Mrs Andrea Morris
Customer address	Ladyburn 13 Main Street Glenluce Newton Stewart DG8 0PN
Prepared by	Shepherd Chartered Surveyors
Date of inspection	05/02/2026

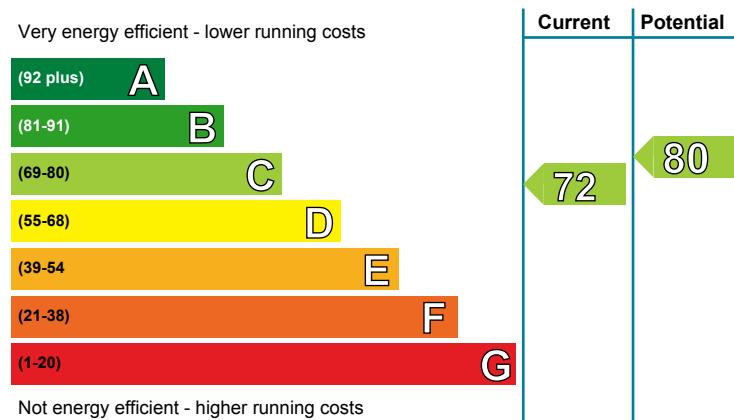
Energy Efficiency Rating

This graph shows the current efficiency of your home, taking into account both energy efficiency and fuel costs. The higher this rating, the lower your fuel bills are likely to be.

Your current rating is **band C (72)**. The average rating for EPCs in Scotland is **band D (61)**.

The potential rating shows the effect of undertaking all of the improvement measures listed within your recommendations report.

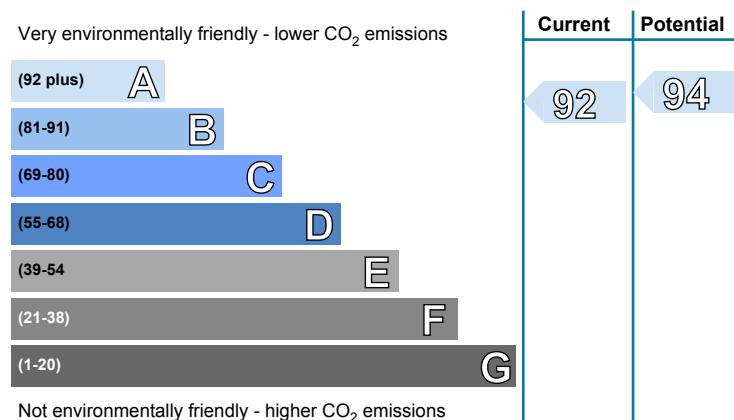
Environmental Impact (CO₂) Rating

This graph shows the effect of your home on the environment in terms of carbon dioxide (CO₂) emissions. The higher the rating, the less impact it has on the environment.
