# Home Report

# Single Survey

## Survey Report on:

14 Bayview Terrace,  
Kirkcolm,  
Stranraer,  
Wigtownshire,  
DG9 0NP

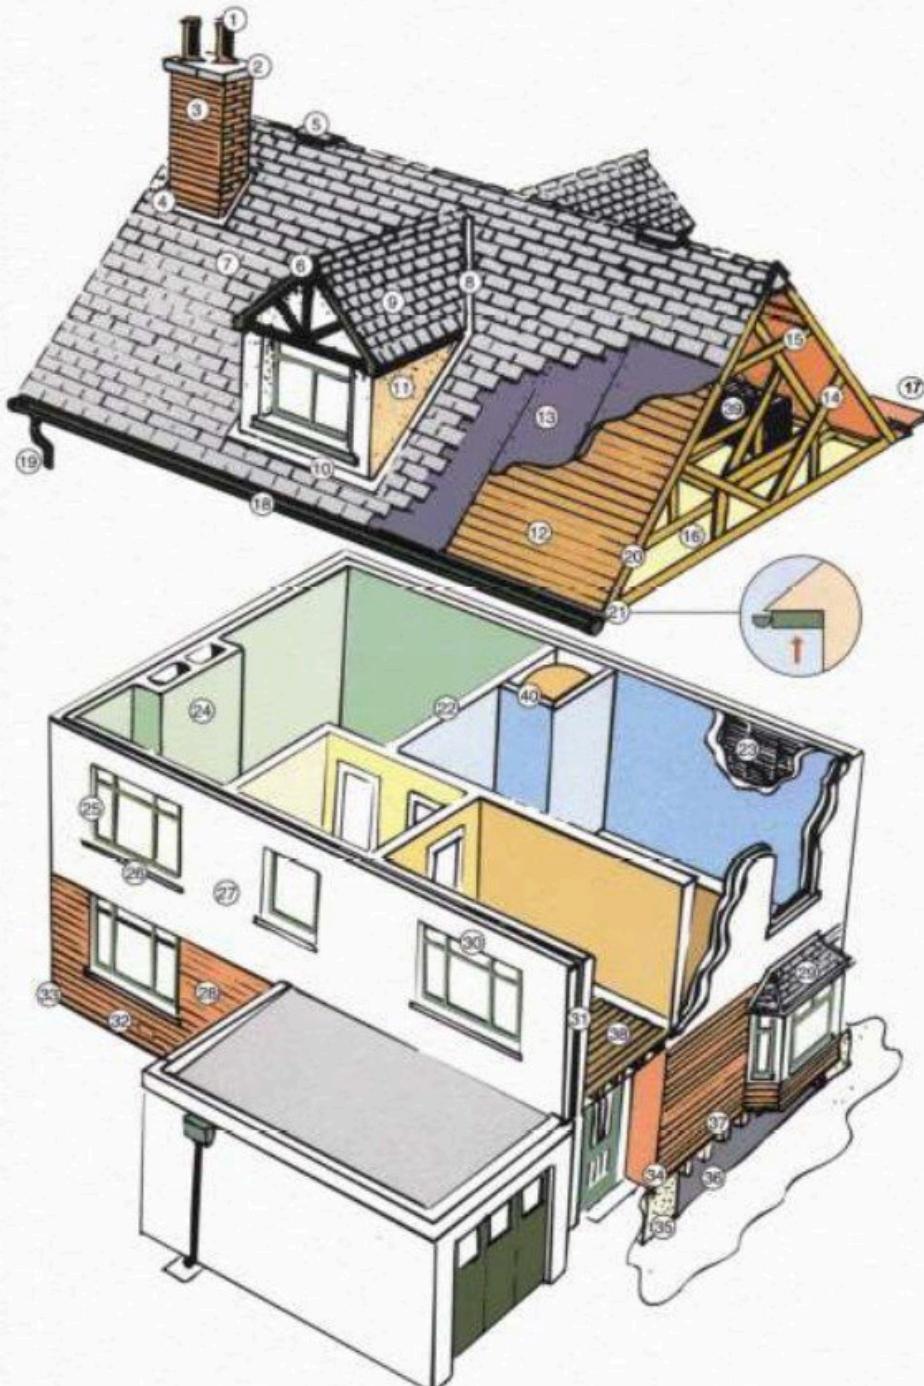
## Sectional Diagram showing elements of a typical house

- 1 Chimney pots
- 2 Coping stone
- 3 Chimney head
- 4 Flashing
- 5 Ridge ventilation
- 6 Ridge board
- 7 Slates / tiles
- 8 Valley guttering
- 9 Dormer projection
- 10 Dormer flashing
- 11 Dormer cheeks
- 12 Sarking
- 13 Roof felt
- 14 Trusses
- 15 Collar
- 16 Insulation
- 17 Parapet gutter
- 18 Eaves guttering
- 19 Rainwater downpipe
- 20 Verge boards / skewers
- 21 Soffit boards
- 22 Partition wall
- 23 Lath / plaster
- 24 Chimney breast
- 25 Window pointing
- 26 Window sills
- 27 Rendering
- 28 Brickwork / pointing
- 29 Bay window projection
- 30 Lintels
- 31 Cavity walls / wall ties
- 32 Subfloor ventilator
- 33 Damp proof course
- 34 Base course
- 35 Foundations
- 36 Solum
- 37 Floor joists
- 38 Floorboards
- 39 Water tank
- 40 Hot water tank

Reference may be made in this report to some or all of the above component parts of the property. This diagram may assist you in locating and understanding these items.
