HOME REPORT

Glencroft, Portpatrick, DG9 9AD

Dwelling type: Detached house
Date of assessment: 24 October 2024
Date of certificate: 30 October 2024
Total floor area: 183 m²
Primary Energy Indicator: 294 kWh/m²/year

Single Survey

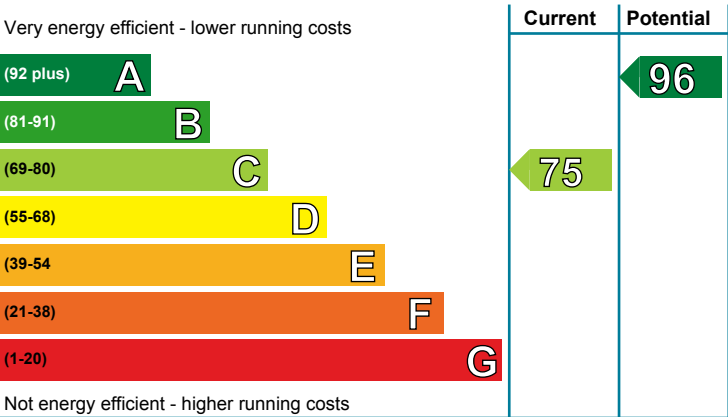
Energy Efficiency Rating

This graph shows the current efficiency of your home, taking into account both energy efficiency and fuel costs. The higher this rating, the lower your fuel bills are likely to be.

Your current rating is **band C (75)**. The average rating for EPCs in Scotland is **band D (61)**.

The potential rating shows the effect of undertaking all of the improvement measures listed within your recommendations report.

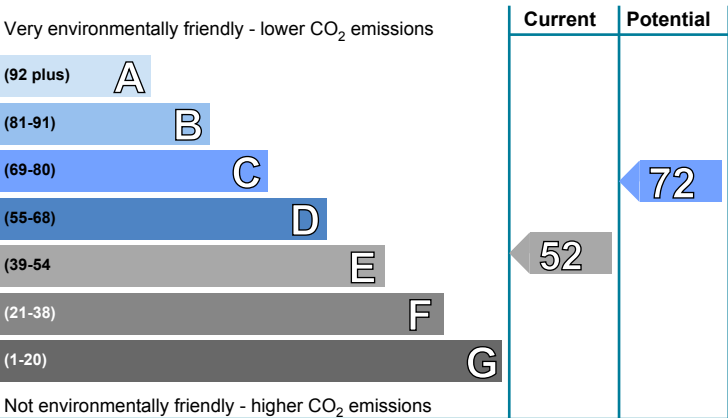
Environmental Impact (CO₂) Rating

This graph shows the effect of your home on the environment in terms of carbon dioxide (CO₂) emissions. The higher the rating, the less impact it has on the environment.

Your current rating is **band E (52)**. The average rating for EPCs in Scotland is **band D (59)**.

The potential rating shows the effect of undertaking all of the improvement measures listed within your recommendations report.

The average Scottish household produces about 6 tonnes of carbon dioxide every year. Based on this assessment, heating and lighting this home currently produces approximately 9.1 tonnes of carbon dioxide every year. Adopting recommendations in this report can reduce emissions and protect the environment. If you were to install all of these recommendations this could reduce emissions by 3.4 tonnes per year. You could reduce emissions even more by switching to renewable energy sources.
