HOME REPORT

HOWPARK LESWALT HIGH ROAD

STRANRAER
DG9 0AN

Energy Performance Certificate (EPC)

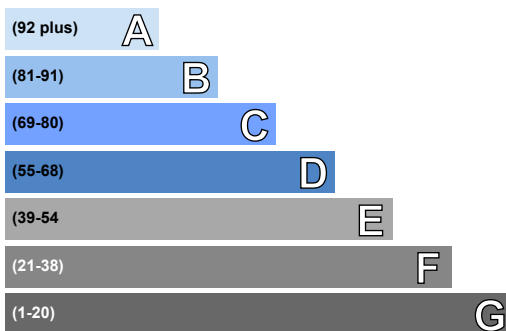
Current	Potential
60	87

The potential rating shows the effect of undertaking all of the improvement measures listed within your recommendations report.
